Army Aircraft Safety Performance

REVIEW

- FY 89 through FY 93 -

- UH-1
- H-60
- AH-1
- AH-64
- H-47D/E
- OH-58A/C
- OH-58D
- Fixed Wing

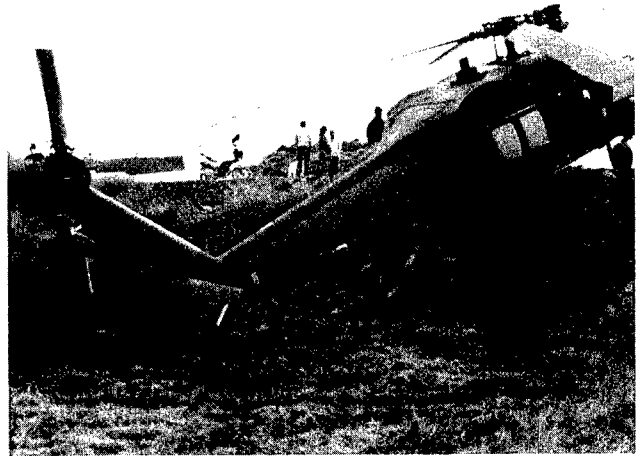
■ **Result:** Damage cost of \$295,004.

■ **Cause:** Crew failed to anticipate and correctly identify an in-flight hazard.

Prevention techniques and procedures: Same as Scenario 1.

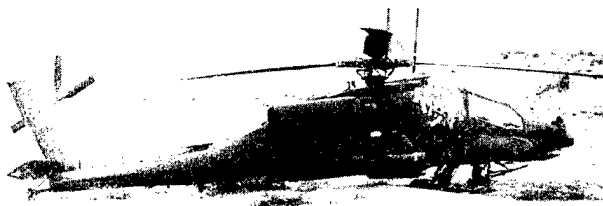
- **Result:** Damage cost of \$975,893.

- **Cause:** Inadequate attention as to their

position off the lead aircraft and the terrain over which they were operating. The aircraft descended below the minimum altitude required by the unit tactical standing operating procedures, which would have kept them clear of the wires.

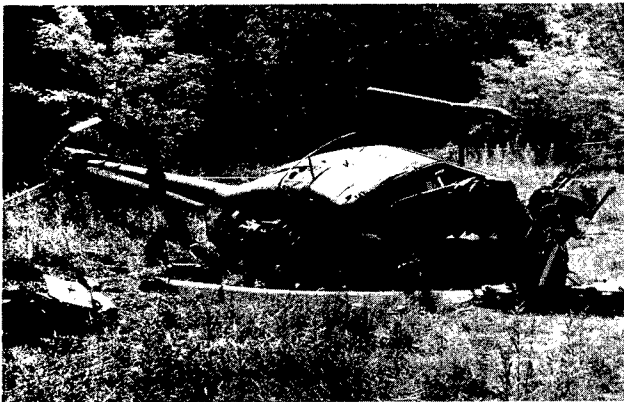
Scenario 1. While attempting a takeoff to a hover from level terrain at a field site, the IP did not properly coordinate his flight controls to establish a vertical ascent as required by TC 1-215, Task 1017. He failed to adjust cyclic input to establish a vertical ascent with the aircraft, which he knew was right-side heavy, and then did not reduce the collective pitch control in time to correct for the developing dynamic rollover condition. As a result, the right roll progressed beyond the aircraft's critical rollover angle and the main rotor blades made ground contact with a 2-foot embankment on the right side of the aircraft.

■ **Result:** A destroyed aircraft and cost of \$92,290.

■ **Cause:** Failure of the IP to adjust cyclic input to establish vertical ascent. The IP's actions resulted from his failure to observe the aircraft roll rate as the left skid left the ground. Contributing to the IP's distraction was his attempt to get the AO to monitor the engine turbine outlet temperature during the takeoff.

Prevention techniques and procedures: Dynamic rollover is an old problem that must be reemphasized periodically. FM 1-203: Fundamentals of Flight and numerous training POIs discuss dynamic rollover in detail. Review them carefully.

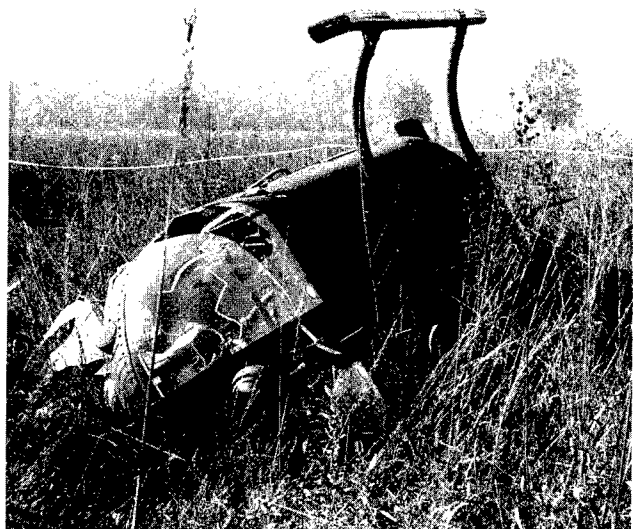
Scenario 2: During a night-aided landing in tall grass, the PC became spatially disoriented and misinterpreted the aircraft's actions. The blowing tall grass and the lack of visual cues, in conjunction with a perceived slope, resulted in the PC becoming spatially disoriented. As a result, he permitted the aircraft to roll right to the point the main rotor blades made ground contact.

■ **Result:** A destroyed aircraft and a cost of \$93,335.

■ **Cause:** Spatial disorientation and overconfidence. Due to the repetitive nature of the missions in which he had been involved for the past 10 days, his more than 100 hours of experience with NVGs, and his awareness of the successful landing of an aircraft in the same area a short time earlier, the PC was lulled into a complacent state of well-being. This business-as-usual attitude contributed to his misinterpretation of what the aircraft was doing as well as a breakdown in crew coordination.

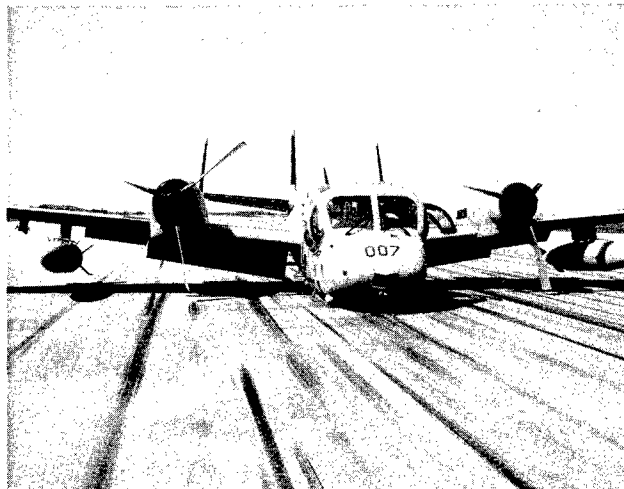
Scenario 2. The crew was performing an RL3 training flight in an OV-1D. While on downwind, the IP simulated failure of the No. 1 engine by reducing the No. 1 engine power lever. The IP announced the engine failure and told the PI to continue the pattern and perform a simulated single-engine landing. The PI continued with a normal pattern. As the aircraft approached the landing runway, the PI and IP noted that the flaps were at zero degrees. The PI applied full flaps. As the flaps extended to full-down position, the aircraft "ballooned." Both pilots had their attention

on the landing attitude of the aircraft. The aircraft continued to the touchdown point and landed gear up.

■ **Result:** Damage cost of \$5,879,892.

■ **Cause:** The IP failed to verify that the PI completed the before-landing or landing check. The IP was preoccupied with another aircraft in the traffic pattern and the change in attitude of his own aircraft during the final landing phase.
